Construction requirements of the Water Supply of Constantinople and Anastasian Wall

J. Riley Snyder

PhD in Archaeology
The University of Edinburgh
2012

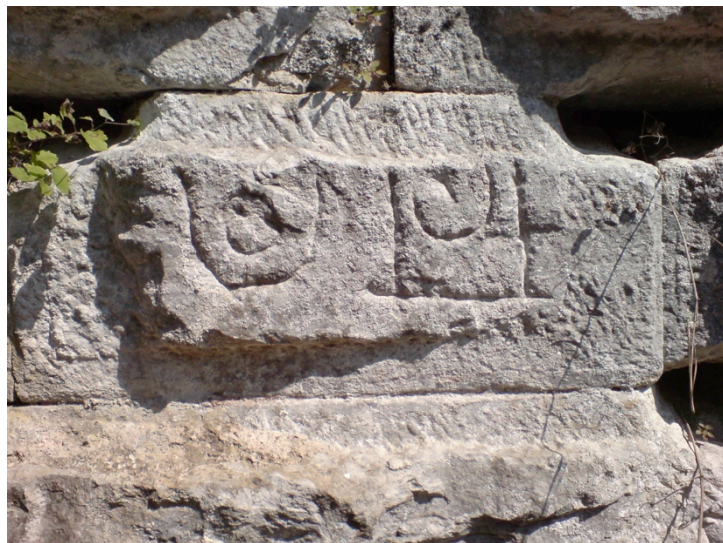
Figure 2.4 - Crystalline limestone block from Kurşunlugerme with drafted margins and mason’s mark.

The other primary structural element of the water supply is aqueduct bridges. In the 4th- and 5th-century phases, aqueduct bridges were constructed with a mortared rubble core faced with stone blocks. In the 4th century, bridges were typically face with rough rusticated limestone blocks and timber cribwork was used to strengthen the core (Crow, Bardill, and Bayliss, 2008: 103). On the whole, bridges of the 5th-century phase were longer and wider (see discussion in section 7.1 of Chapter 7). In the largest of these, which Crow, Bardill, and Bayliss (2008) coin as ‘monumental bridges’, they are faced with large metamorphosed limestone blocks fastened by iron clamps set in lead. These blocks are commonly quarry-dressed with drafted margins and typically contain a mason’s mark (Figure 2.4). The longest and widest of these bridges, Kurşunlugerme, is buttressed.

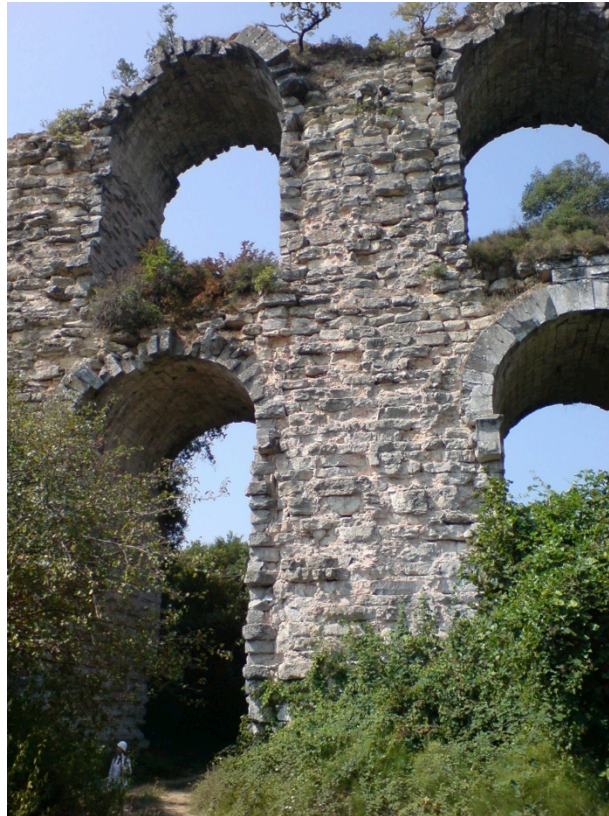
Figure 2.5- Exposed mortar rubble core from Kumarlıdere (K31).

stones (Figure 2.4). The best evidence for this comes from 5th-century monumental bridges like Kurşunlugerme and Kumarlıdere where, most likely due to seismic events, the facing stones have sheered off to reveal the mortar rubble core (Figure 2.5). This has revealed almost entire portions of the outermost core consisting of pink mortar surrounding rough stone.

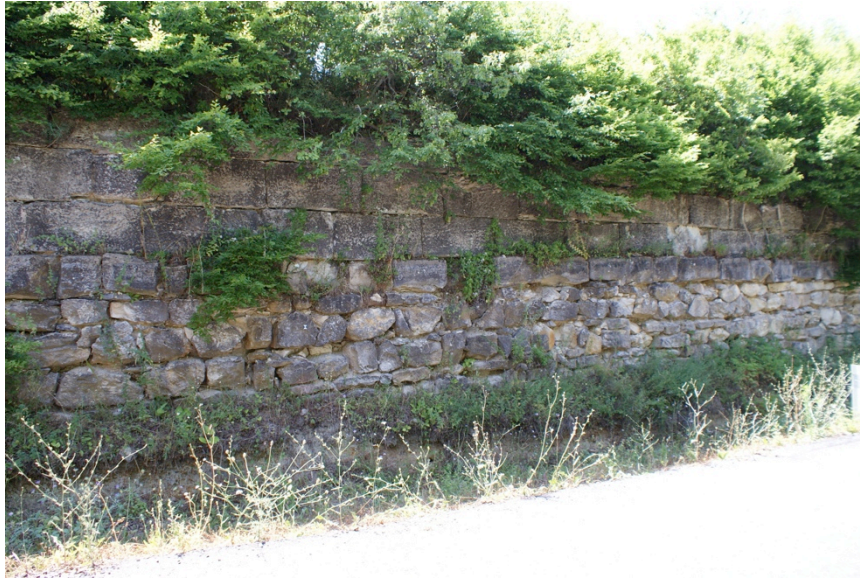
Figure 2.7 - Well preserved portion of curtain wall along the road leading to Evcik. Notice the alternating courses of large crystalline limestone blockwork and rough quarried stone facing.

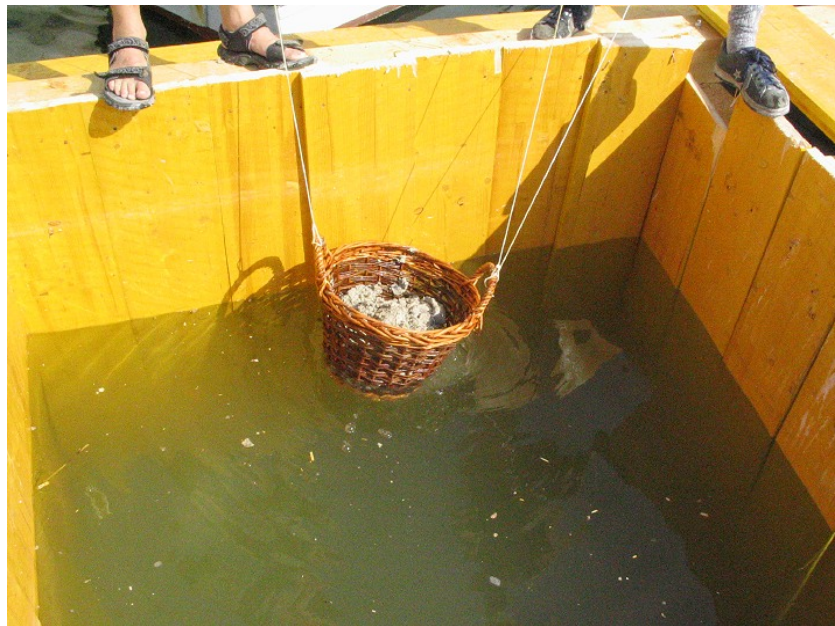
Figure 4.1 – Basket being lowered into wooden formwork created by the ROMACONS project (after Hohlfelder et al., 2005: 126).

The team made mortar from Vitruvius' formula, which called for two parts pozzolana and one part lime together with 15 to 20% seawater (Adam, 1999). It was mixed together in a trough using variations of Roman building tools such as shovels, rakes, and mattocks as shown by writings, depictions, and material remains from the archaeological record. The team intentionally made the mixture very thick because, when dropped into the formwork, there would be no risk of it diluting into the water. This made it easy to pour into the form using two men and specifically designed wicker baskets to lower the cement into the form (Figure 4.1).

The first layer of cement was 0.2 m thick and rested directly on the freshly laid beach sand. The new surface was compacted down and smoothed out with rakes and mattocks and then the aggregate was placed in a new layer to cover the entire area. It took eight days to completely fill the form using this layering process (Hohlfelder et al., 2005: 126). Within a day of laying the last layer of mortar, the concrete had set well enough to walk on without sinking or shifting. Finally, a layer of smooth mortar was placed over the layer of aggregate, levelled using trowels, and paved using tuff blocks (Hohlfelder et al., 2005: 126).

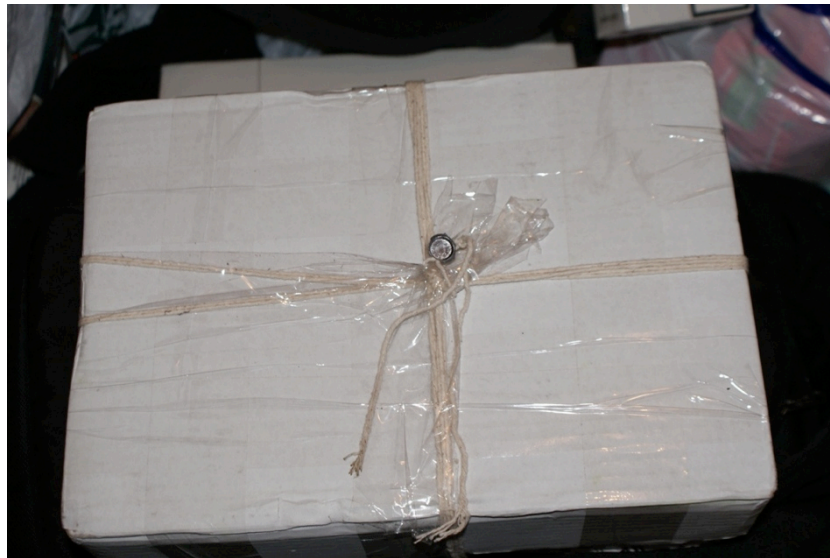
Figure 5.1 - Sealed box of samples of mortar from the Anastasian wall.

Before the samples could be transported out of Turkey, they had to be inspected by the staff at the Istanbul Archaeological Museum. After the inspection, permission was given in writing stating that the samples were authorised for export for scientific analysis. A member of the museum staff then placed the samples in a box, sealing it with string and secured with lead seal. This was to ensure that nothing was added or removed from the box before being taken out of the country.

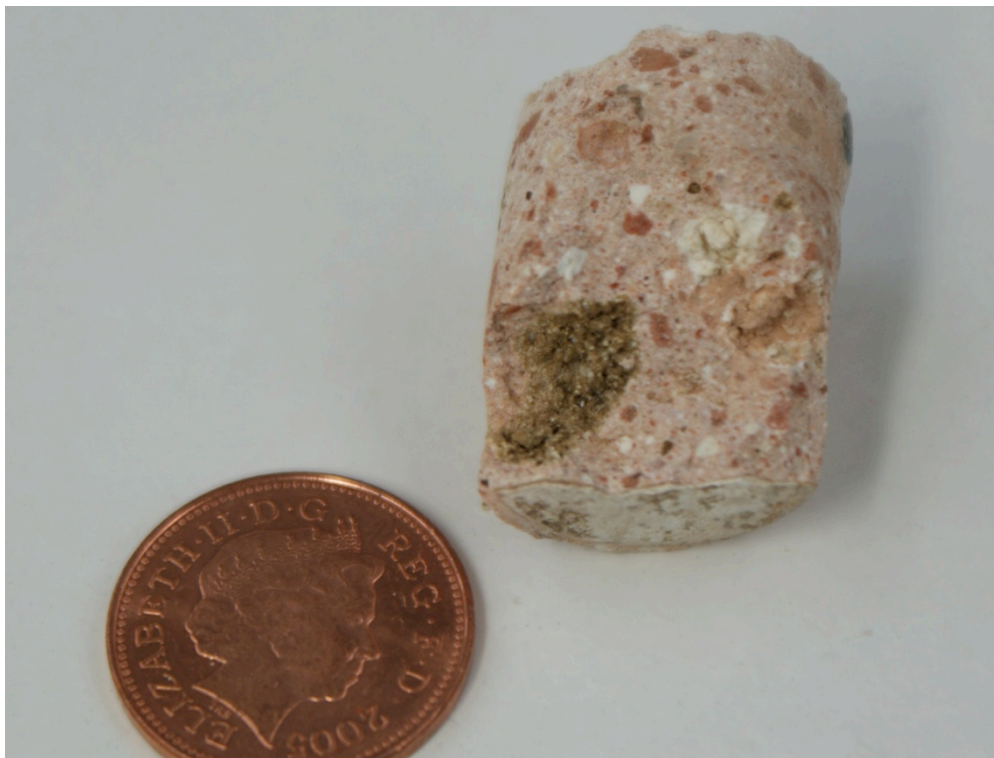
Figure 5.2 - Core sample of channel mortar from Karatepe. The core fractured during the drilling process, revealing a pocket filled with possible decayed organic material.

This process proved to be useful beyond the necessary means of obtaining a core. Observations were made about a sample's current state of quality, its general porosity, and the samples friability. Cores provided information about large pores and fissures that occurred within the sample that were not readily identifiable on the surface.

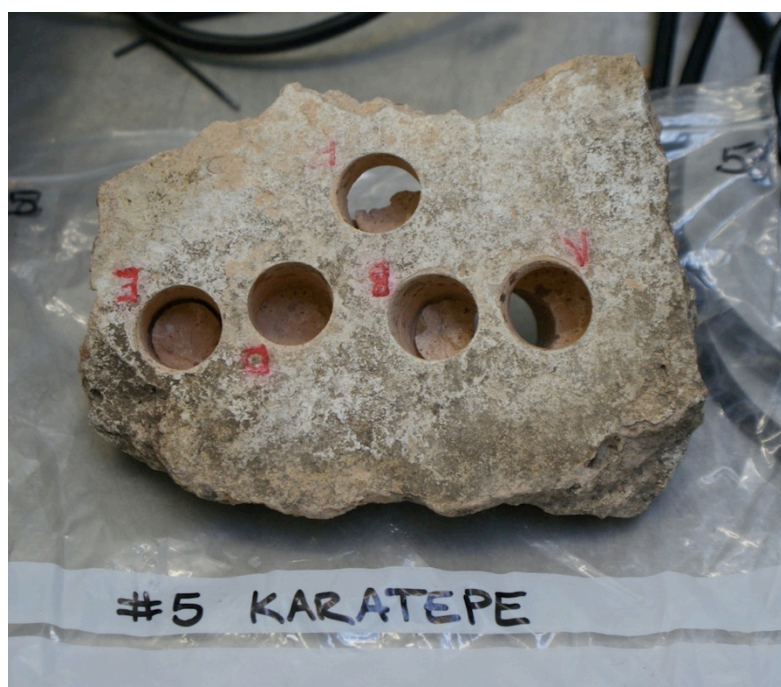
Figure 5.3 - Channel lining mortar from Karatepe with holes from coring.

most samples, this meant choosing at least three locations spread out over the surface for drilling. It was not required to break up the sample to get to the core since the drill bit could take cores to a depth of 4 cm. Even for thick samples that were like that from Kurşunlugerme, it was possible to start drilling another core in the same location after the first core was removed. In the case of channel lining mortar from Karatepe, it was possible to take a total of five cores from the surface in contact with the water flow. The distance between cores were the most concentrated on this sample because of the thin nature of the sample and the depth obtainable by the coring bit. It was only necessary to take one core from the opposite side at the thickest point of the sample.

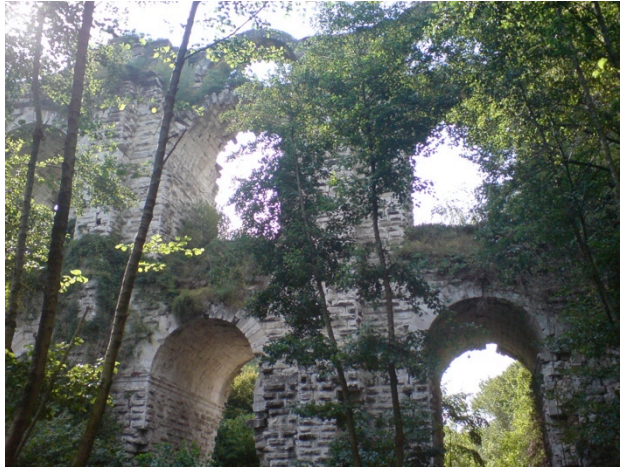
Figure 6.1 - Kurşunlugerme (K20).

The first sample came from the Kurşunlugerme (K20), which is located 3.6 km northeast of Gümüşpınar and is the most western collection site in Thrace (Figure 6.1). It is the longest and widest aqueduct bridge other than the Aqueduct of Valens in Constantinople, built of three tiers with 18 arches and eight buttresses extending up to the third tier (Crow, Bardill, and Bayliss, 2008: 93). This bridge carries the narrow channel on the top tier and wide channel on the middle (Crow, Bardill, and Bayliss, 2008: 93). The mortar sample, designated 'TT-WS 1', was collected from the exposed core on the inner face of the northern-most arch (18), which had been protected by the intact arch above.

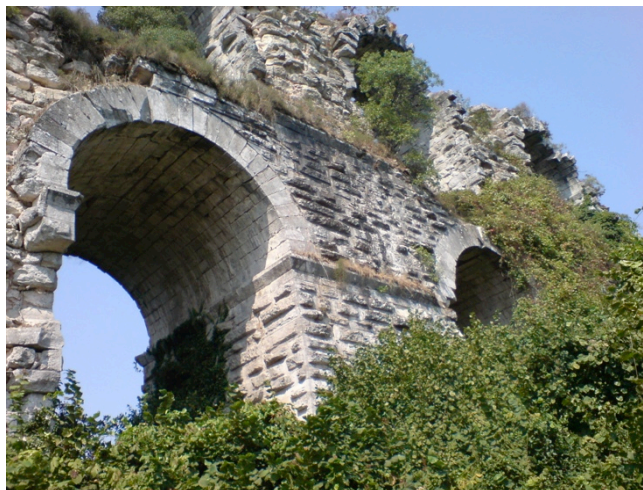
Figure 6.2 - Kumarlıdere (K31).

The second sample, TT-WS 2, came from Kumarlıdere (K31), another bridge that illustrates the monumental nature of fifth-century aqueduct bridge construction (Figure 6.2). This bridge is located about 3 km northwest of the village of Kalfaköy and represents the eastern-most collection sites on the water supply. Kumarlıdere was two tier bridge with 11 arches on the upper and four taller arches on the lower. The bridge had long earthen embankments leading from the side of the hills to the ends of the bridge (Crow, Bardill, and Bayliss, 2008: 100). Sample TT-WS 2 was located on the western side of the bridge and had already completely fallen away from its original location. Based on the sample's proximity, it can be supposed to have come from a nearby exposed portion of the core structure on the first pier's southern face.

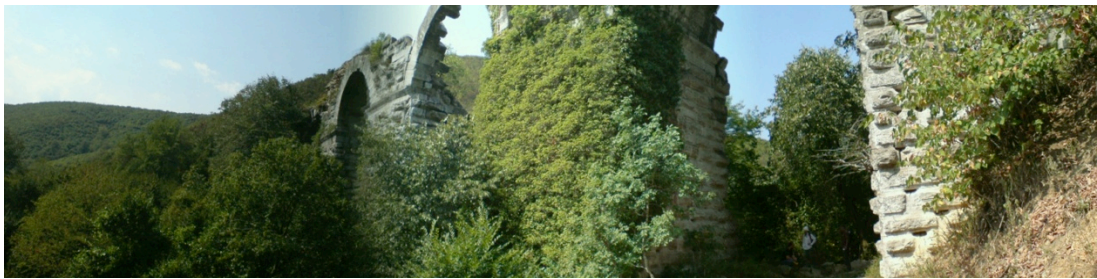
Figure 6.3 – Upper arches of Keçigerme (K31).

The third mortar collection site is less than one kilometre east of Kumarlıdere (K31) at Keçigerme (K30). This bridge is the smallest in terms of length and width of the monumental bridges used as collection sites in this project but is nevertheless important due to its towering height, comparable to both Kumarlıdere and Kurşunlugerme. Keçigerme (Figure 6.3) is situated in a deep and densely forested valley with only one lower arch and five tall upper arches (Crow, Bardill, and Bayliss, 2008: 99). A piece of structural core mortar was found *in situ* but naturally fractured away from the core matrix, making it a good candidate for minimally intrusive sampling. This sample, TT-WS 3, was taken from the south-western region of the lower tier of the aqueduct, about three metres up from the foot of the valley.

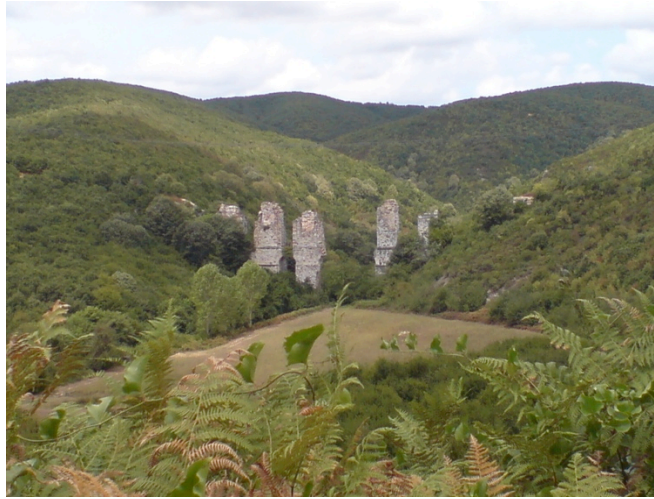
Figure 6.4 - Büyükgerme (K29).

The fourth sample of mortar was taken from the second largest monumental bridge, Büyükgerme (K29), and is located 2.5 km southwest of the village of Çiftlikköy and 2.3 km northwest of Keçigerme. While most of the arches of the bridge are now collapsed, all but one pier still stands. Büyükgerme (Figure 6.4) would have had three arches on the lower tier and nine arches on the upper (Crow, Bardill, and Bayliss, 2008: 97). Sample TT-WS 4 was collected from the northern side of the valley and more than halfway up the embankment. This was found as a part of a pile of building materials that looked to have broken from the core during the same event that caused a few facing stones to fall away from lower portion of the second pier from the north of the upper tier.

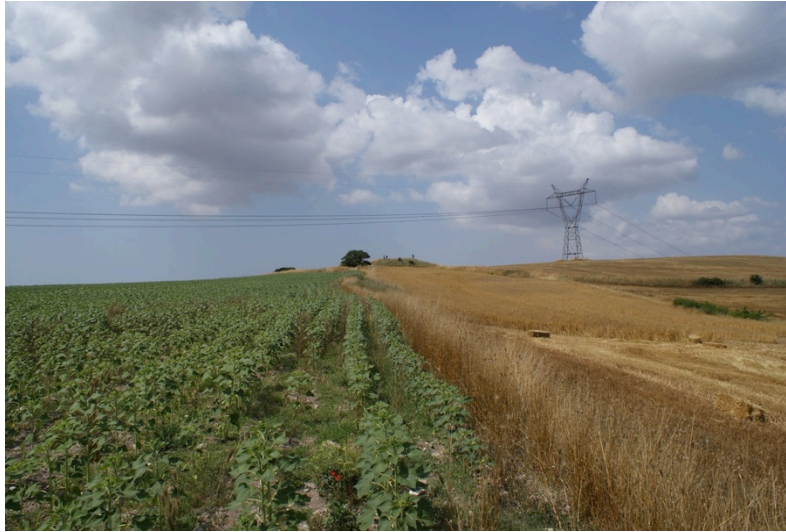
Figure 6.5 - Collection site of TT-AW 1 (Karanlik Ayazma Sirti).

The first collection site along the Anastasian Wall was about 3 km north of the village of Kurfalı at Karanlık Ayazma Sirti (Figure 6.5). Here, one mortar sample, TT-AW 1, was collected about 100 m south of an earthen mound where there were remains of a tower. The path of the curtain wall was identified by the abundance of rubble strewn about two adjoining planted field plots and the small grassy bump that served to separate them. Because there was no evidence of intact portions of wall in this area, the sample was collected from the debris of the western field, closest to the divider.

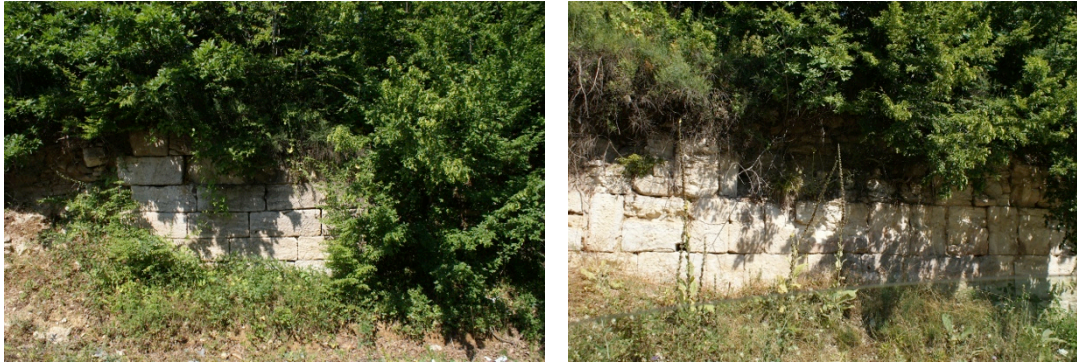
Figure 6.6 – Mortar Collection site of TT-AW 2 and 3 (Belgrat Tower).

The second location for sample collection provided two separate mortar samples. Both samples TT-AW 2 and TT-AW 3 were collected from a well preserved section of curtain wall immediately vicinity of Belgrat Tower (**Error! Reference source not found.**), located 2.3 km northwest of the village of Belgrat. Sample TT-AW 2 was collected from the northern end of a 2 m stretch where the upper facing stones had fallen away. This piece of core mortar was taken from behind the one of the disjointed facing stones and was already fractured free from the matrix, most likely from the event that caused parts of the wall's face to fall away. The second sample, TT-AW 3, came from an area about 5m down from the first sample site at Belgrat Tower at roughly the same course height of 1.5m from the current base of the wall. This location was different from the first as there was no embankment of rubble created from the exposed core materials. Instead, this are looked to be intentionally recessed into the wall with the facing stone perfectly accommodating this feature. The mortar sample was taken from the recessed area that looked to be made of similar materials as the mortared rubble core of the first collection site, possibly with the intention of rough courses of mortared rubble stone. This section of the wall was faced with large, cleanly cut soft limestone blocks.

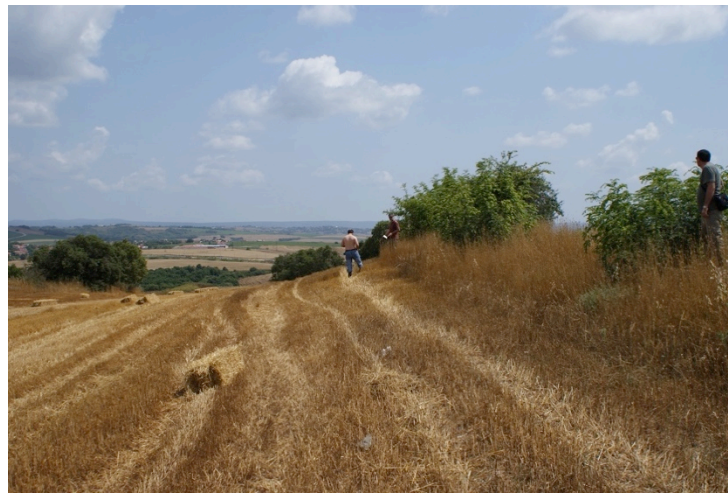
Figure 6.6 - Collection site for mortar sample TT-AW 4 (Çilingir).

The next mortar sample came from the southernmost collection site of the Anastasian Wall. This location, known as Çilingir (Figure 6.6) is 1.5 km southwest of the village of Kurfalı and around 15 km from the southern terminus of the wall on the Sea of Marmara. The line of the wall was similar to Karanlık Ayazma Sirti but had a more pronounced mound with vegetation growing on the top, again seeming to be used to separate modern agricultural plots. Sample TT-AW 4 was found on the western embankment disassociated from any intact structural feature of the wall but in a pile of other rubble construction material close to where the core of the structure would be located.

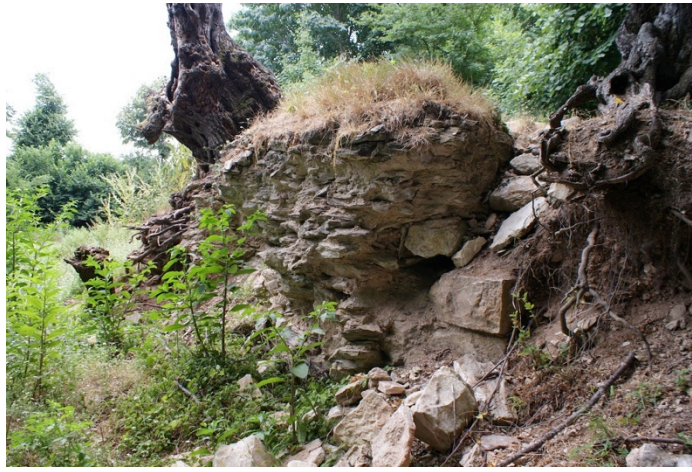
Figure 6.7 - Collection site for mortar Sample TT-AW 5 (B y k Bedesten).

section of the curtain wall. Furthermore, the structural function of sample TT-AW 5 was also different from the rest of the samples, making it an important addition for comparative analysis. Its collection site is a fort on the line of the wall called Büyük Bedesten (Figure 6.7) and is located 2.7 km east of the monumental aqueduct of K rs n l germe (K20). While not *in situ* upon collection, based on its immediacy to the remains of the northeast tower of the fort along with which numerous whole bricks and stones were found, TT-AW 5 looked to be the remains of a mortar joint. Also, based on other observations of the morphology of the sample, which will be discussed in greater detail later in this section, it is most likely a whole joint from a vaulted brick arch.

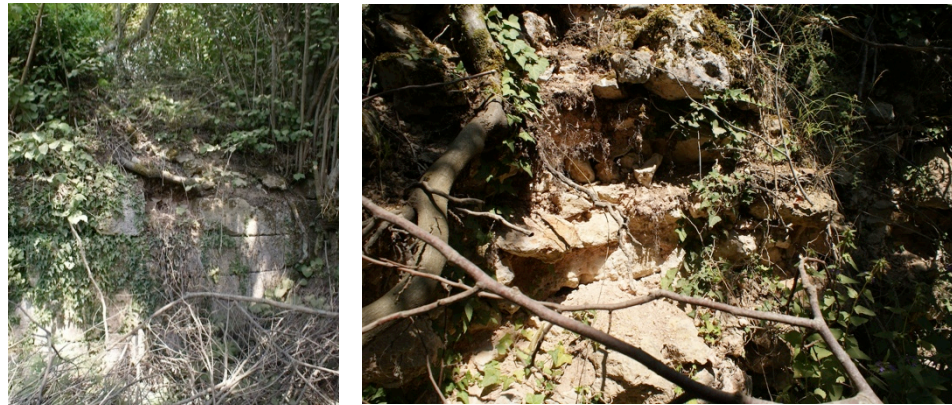
Figure 6.8 - Collection site of mortar samples TT-AW 6 and 7 (South Derviş Kapi).

The next mortar collection site comes from another curtain wall section just south of the Derviş Kapı fort (Figure 6.8). This site is located 2 km south of the K c k Bedesten fort, 6 km south of B y k Bedesten and around 3 km southeast of the village of G m şpınar. Two mortar samples were collected from a tall section of wall in an area of intense vegetation. The first sample, TT-AW 6, came from an exposed section about 1m from the modern ground level of the wall. Again, based on the surrounding architecture, this piece of mortar would have been applied to the inner core of a course made of large limestone blocks. The second sample, TT-AW 7, was collected from a location only 5 m away from the first and at height of roughly 2 m. This particular height of wall did not survive with facing materials still intact along the visible length. Because of this, it is difficult to say with certainty whether this was a part of the same small blockwork course or whether it was a part

of the large limestone ashlar block courses as evidenced by other sections of the wall and the broken remains of ashlar blocks in proximity to the wall.

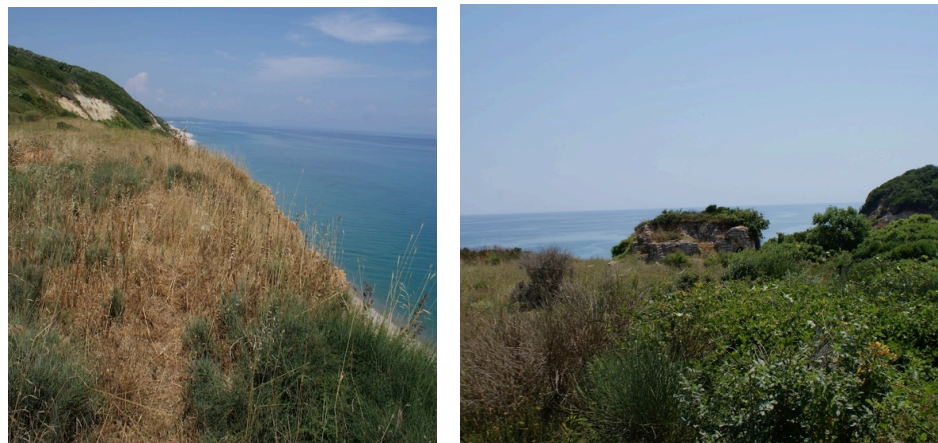
Figure 6.9 - Collection site for mortar sample TT-AW 8 (Evcik).

The last collection site was at the northernmost section of the wall at Evcik (Figure 6.9). This area of curtain wall is located on the sandstone cliffs of the Black Sea coast 5 km north of Karacaköy and less than 50 m west of a small middle Byzantine Church. The sample TT-AW 8, taken from the exposed mortar core around 1.5m above the modern base on the wall's western side, could not be identified as a mortar joint or part of the large ashlar-faced mortared rubble known. This was due to the previous removal of facing stones most likely used for construction in the nearby church (Crow and Ricci, 1997), the poor preservation of the remaining wall matrices, and the overgrowth of vegetation along the entire section. Had there not been a visible area of the core, most likely exposed by weathering and crumbling of the surface material and subsequent vegetative cover, it would have been rather difficult to be able to identify this earthen mound as a section of wall.

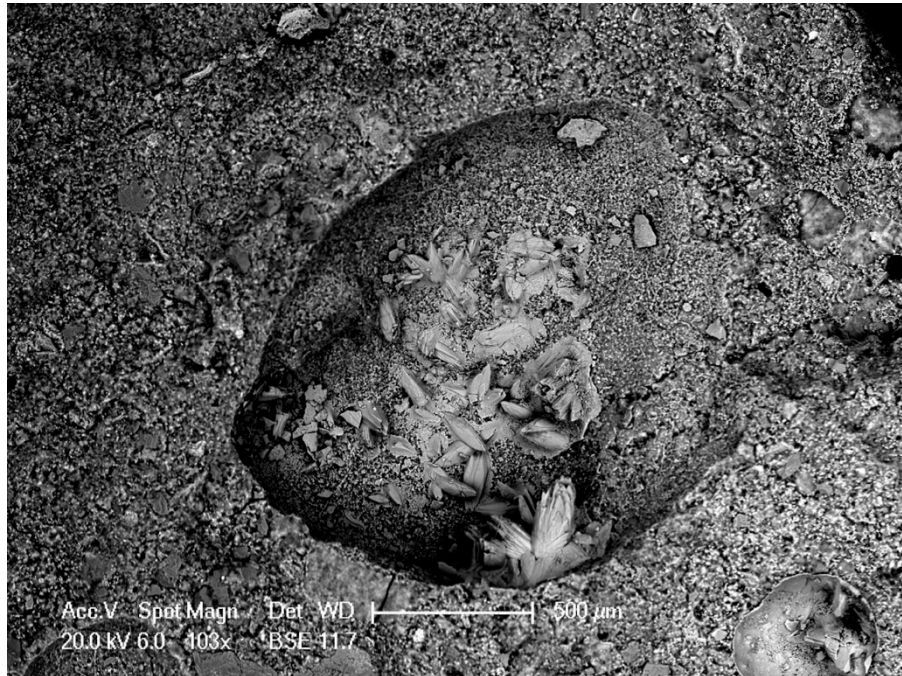
Figure 6.20 - SEM photograph of large pore from sample TT-WS 4 (Büyükgerme) with secondary calcite crystal formations.

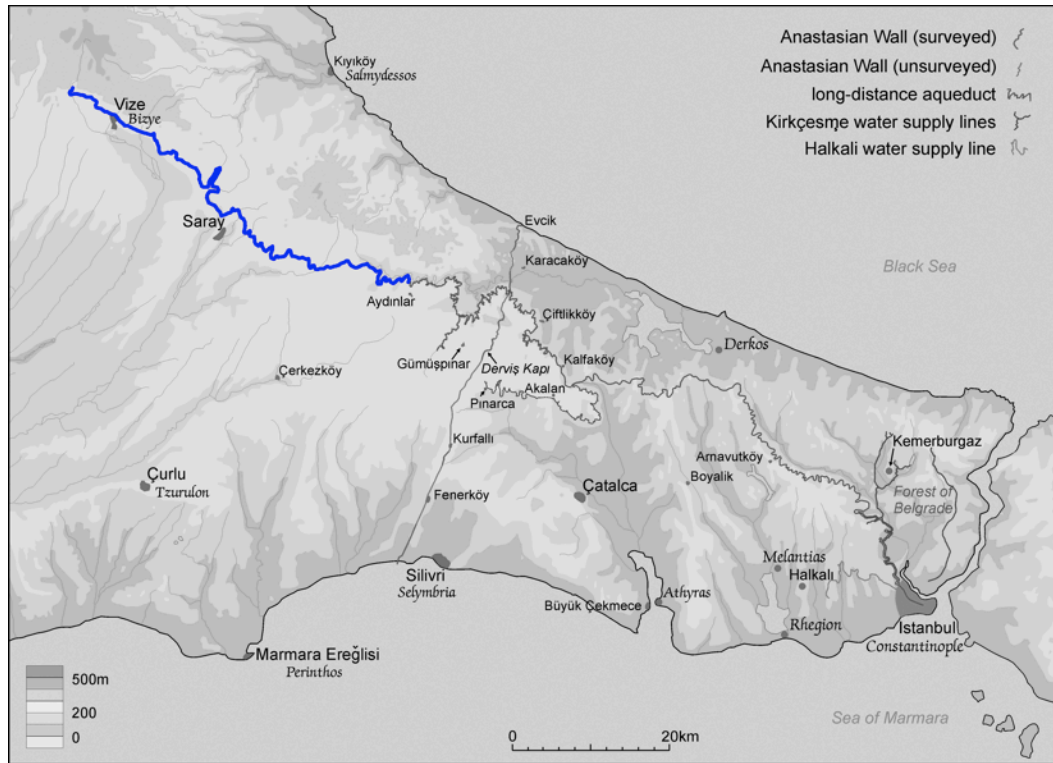
Map 7.4 - Section of 5th-century phase of the water supply from the furthest water source (Pazarlı spring) to Manganez Dere bridge (K9).

The first part of the water supply to be measured was the narrow channel line that extends furthest west. This begins at the spring source at Pazarlı spring (240 m ASL), continues through the town of Vize to the aqueduct bridge of Manganez Dere. With little variation, this channel averages a width of 0.7 m, qualifying it as a narrow channel. The total length of this stretch of channel measures a little over 51 km, which included 13 bridges (Crow, Bardill, and Bayliss, 2008: 29-42).

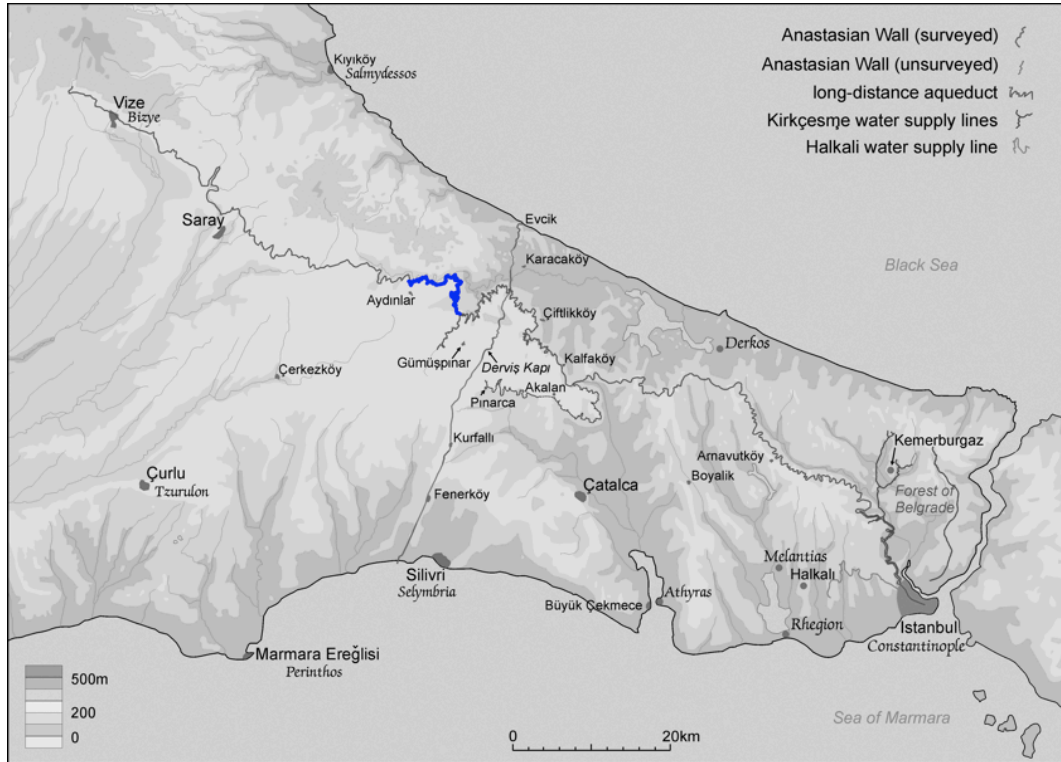
Map 7.5 - Section of 5th-century phase of the water supply from Manganez Dere (K9) to Ballıgerme (K18).

This next section of the fifth-century line of the water supply line continues from the last measured section at the beginning of Manganez Dere. A small length of broad tunnel was observed on the east side of the site of the bridge, marking the beginning of the calculations for the length of this stretch. Over the entire distance of this section, the channel remains wide at an average of 1.6 m. The distance from the last measured section to Ballıgerme was found to stretch over 80 km and included 13 bridges (Crow, Bardill, and Bayliss, 2008: 42-53).

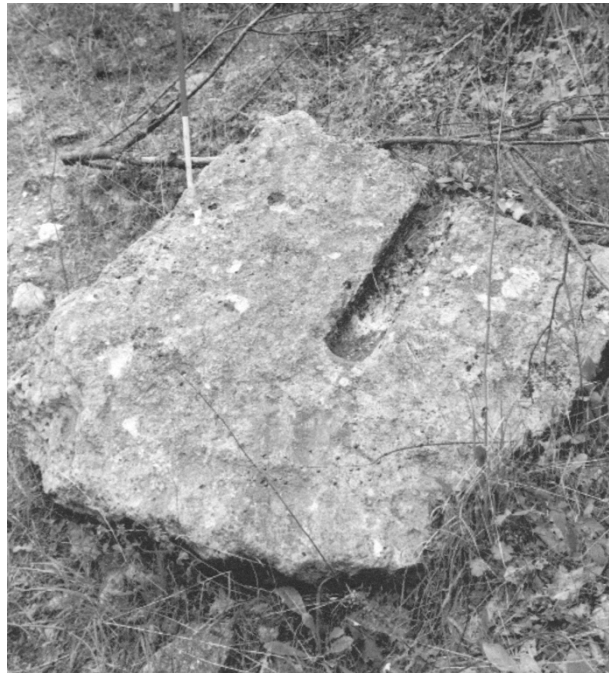
Figure 7.1 - Clamp socket from Cineviz Dere (K11) (after Crow, Bardill, and Bayliss, 2008: 46)

Now that we have established roughly how many stones were necessary, we can make an inference about the total quantity of iron clamps were needed to hold them together, under the assumption that iron clamps were used at each bridge (see Chapter 2 for a discussion of evidence). It is estimated that each stone would have one entire iron clamp, with the exception of the vaulting stones. This amounted to an estimated total of a little over 610,000 clamps. An iron clamp socket (Figure 7.1) from Cineviz Dere (K11) was measured at a volume of roughly 720 cm^3 , taking into account a small margin for sealing lead. The total mass of iron clamps necessary for the faces of the aqueduct bridges would have been approximately 3,400 tonnes. Interestingly, the name of the monumental aqueduct bridge of Kurşunlugerme (K20) means “the leaded span”, referencing the clamps and lead settings recovered during later robbing (Crow, Bardill, and Bayliss: 58).

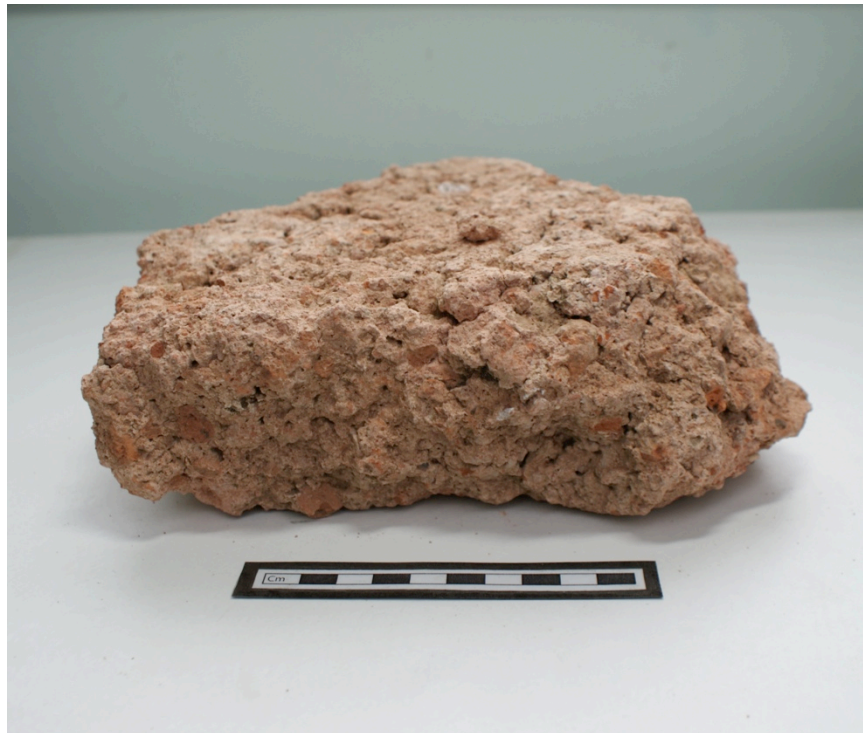
Figure 8.1 - Sample TT-AW 5 from Büyük Bedesten. Notice the slight taper from right to left and the large size and quantity of brick aggregate

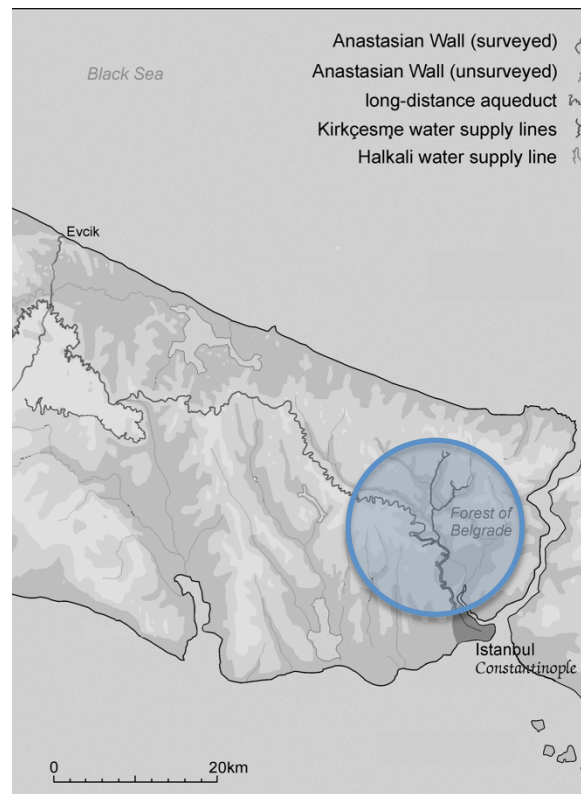
Map 8.1 - Estimated area of forest needed to meet the fuel requirements of the fifth-century phase of the Water Supply of Constantinople (after Crow, 2007: 269).
